Soil and Water Conservation for a Sustainable Improvement of local Agriculture and Living conditions for Marginalized Families in Tiruchuli Taluk,

Virudunagar District, Tamilnadu

STUDY OF THE LOCATION, SOIL TYPES, SLOPE AND TOPOGRAPHY OF THE PROPOSED WATERSHEDS IN NARIKUDI & TIRUCHULI BLOCKS JULY 2013

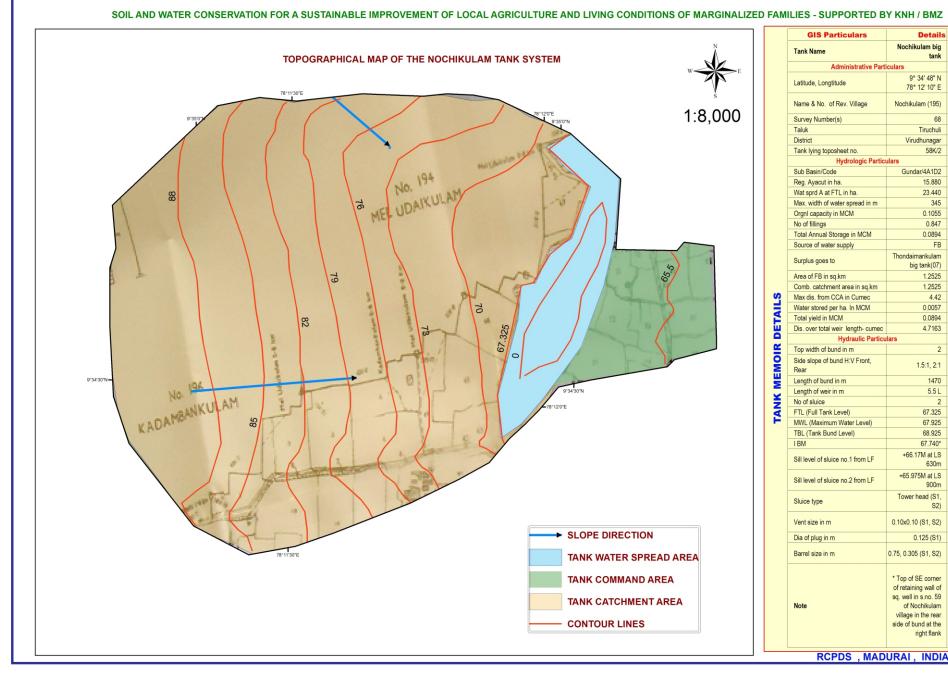
Nochikulam Lake

GIS Particulars	Details
Tank Name	Nochikulam big tank
Administrative Parti	
Latitude, Longtitude	9° 34' 48" N 78° 12' 10" E
Name & No. of Rev. Village	Nochikulam (195)
Survey Number(s)	68
Taluk	Tiruchuli
District	Virudhunagar
Tank lying toposheet no.	58K/2
Hydrologic Particu	
Sub Basin/Code	Gundar/4A1D2
Reg. Ayacut in ha.	15.880
Wat sprd A at FTL in ha.	23.440
Max. width of water spread in m	345
OrgnI capacity in MCM	0.1055
No of fillings	0.847
Total Annual Storage in MCM	0.0894 FB
Source of water supply	
Surplus goes to	Thondaimankulam big tank(07)
Area of FB in sq.km	1.2525
Comb. catchment area in sq.km	1.2525
Max dis. from CCA in Cumec	4.42
Water stored per ha. In MCM	0.0057
Total yield in MCM	0.0894
Dis. over total weir length- cumec	4.7163
Hydraulic Particu	
Top width of bund in m	2
Side slope of bund H:V Front, Rear	1.5:1, 2:1
Length of bund in m	1470
Length of weir in m	5.5 L
No of sluice	2
FTL (Full Tank Level)	67.325

MWL (Maximum Water Level)	67.925
TBL (Tank Bund Level)	68.925
IBM	67.740*
Sill level of sluice no.1 from LF	+66.17M at LS 630m
Sill level of sluice no.2 from LF	+65.975M at LS 900m
Sluice type	Tower head (S1, S2)
Vent size in m	0.10x0.10 (S1, S2)
Dia of plug in m	0.125 (S1)
Barrel size in m	0.75, 0.305 (S1, S2)
Note	* Top of SE corner of retaining wall of sq. well in s.no. 59 of Nochikulam village in the rear side of bund at the right flank
RCPDS , MAD	URAI, INDIA

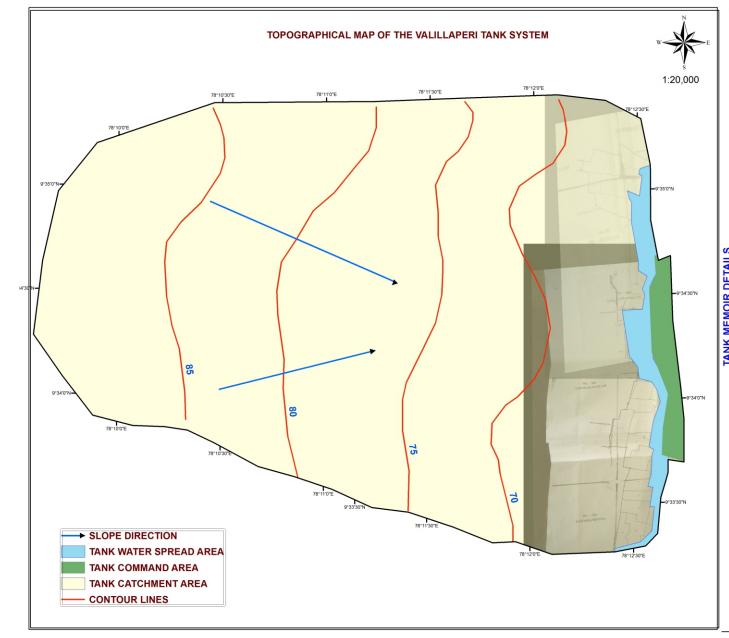
Vaalilaperi Lake

GIS Particulars	Details
Tank Name/code	Vallilaperi tank/4A1D2/38/02
Administrative Pa	
Latitude, Longtitude	9° 34' 23" N 78° 15' 35" F
Name & No. of Rev. Village	Tiruchuli (161)
Survey Number(s)	1
Taluk	Tiruchuli
District	Virudhunagar
Tank lying toposheet no.	58K/2
Hydrologic Particulars	
Cascade/Code	Sennilakudi
Cascade/Code	Cascade/4A1D2/38
Sub Basin/Code	Gundar/4A1D2
Reg. Ayacut in ha.	27.750
Wat sprd A at FTL in ha.	51.390
Max. width of water spread in m	380
OrgnI capacity in MCM	0.2696
No of fillings	0.504
Total Annual Storage in MCM	0.1360
Source of water supply	FB, Sriramanendal(03), Nochikulam small (04)
Surplus goes to	Sennilaikudi tank(01)
Surplus through	Channel
Capacity of tank above in MCM	0.21951
Area of FB in sq.km	1,507
No of Tanks Above	2
Comb. catchment area in sq.km	3.501
Max dis. from CCA in Cumec	12.34
Water stored per ha. In MCM	0.005043
Total yield in MCM	0.136
Dis. over total weir length- cumec	12.8

Hydraulic Partic	
Top width of bund in m	2
Side slope of bund H:V Front, Rear	1.5:1, 2:1
Revetment	Not Revetted
Length of bund in m	2310
Length of weir in m	40.15 L
No of sluice	40.15 L

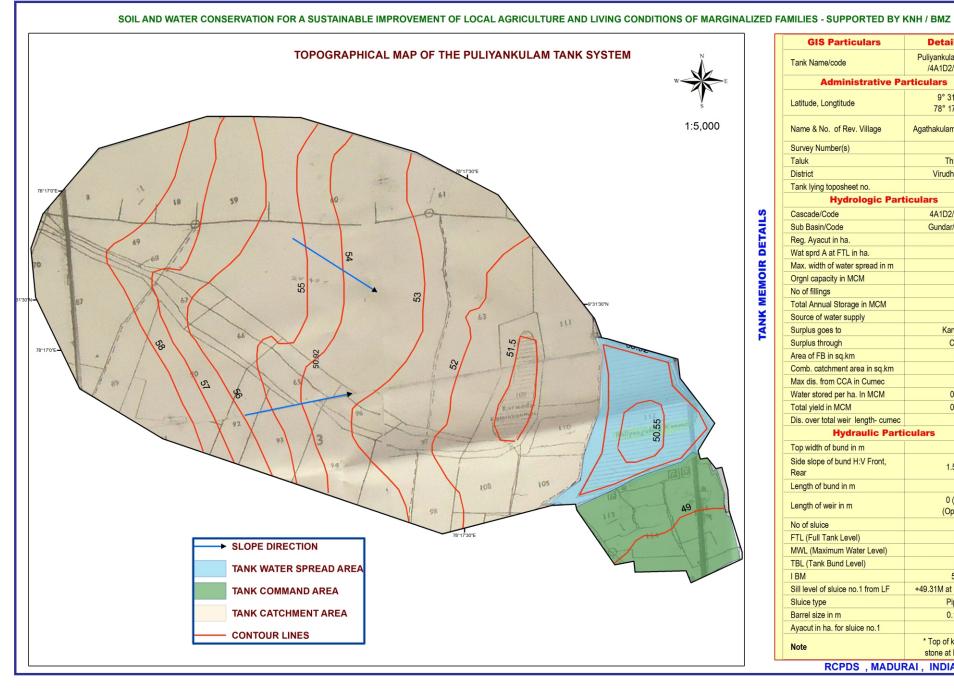
Puliyankulam Lake

GIS Particulars	Details
Tank Name/code	Puliyankulam tank /4A1D2/ISO/32
Administrative Pa	rticulars
Latituda Lamatituda	9° 31' 44" N
Latitude, Longtitude	78° 17' 47" E
Name & No. of Rev. Village	Agathakulam (110)
Survey Number(s)	112
Taluk	Thiruchuli
District	Virudhunagar
Tank lying toposheet no.	58K/6
Hydrologic Part	
Cascade/Code	4A1D2/ISO/32
Sub Basin/Code	Gundar/4A1D2
Reg. Ayacut in ha.	6.280
Wat sprd A at FTL in ha.	9.790
Max. width of water spread in m	340
Orgnl capacity in MCM	0.0767
No of fillings	1.000
Total Annual Storage in MCM	0.0767
Source of water supply	FB
Surplus goes to	Kanal odai
Surplus through	Channel
Area of FB in sq.km	0.2356
Comb. catchment area in sq.km	0.2356
Max dis. from CCA in Cumec	29.34
Water stored per ha. In MCM	0.01232
Total yield in MCM	0.01681
Dis. over total weir length- cumec	29.34
Hydraulic Parti	culars
Top width of bund in m	2
Side slope of bund H:V Front, Rear	1.5:1. 2:1
Length of bund in m	1175

Length of weir in m	0 (or) 3 R
	(Open cut)
No of sluice	1
FTL (Full Tank Level)	50.920
MWL (Maximum Water Level)	51.370
TBL (Tank Bund Level)	52.370
I BM	51.790*
Sill level of sluice no.1 from LF	+49.31M at LS 870
Sluice type	Pipe (S1)
Barrel size in m	0.15 (S1)
Ayacut in ha. for sluice no.1	
Note	* Top of kandam
	stone at RF end

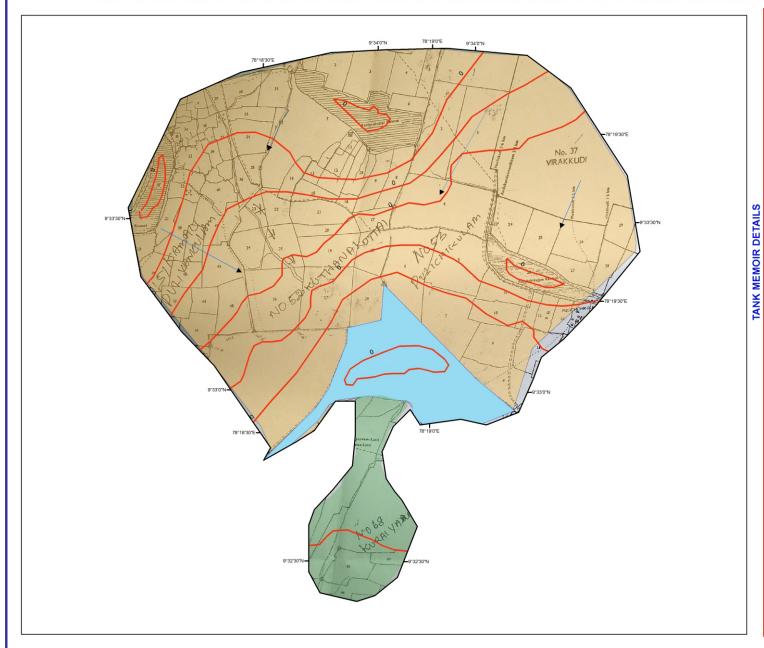
Cittavanankulam Lake

GIS Particulars	Details
Tank Name/code	Chita Vannankulam
Administrative De	kanmoi/4A1D2/29/19
Administrative Pa	9° 33 ' 10.827" N
Latitude, Longtitude	78° 18' 54.248" E
Name & No. of Rev. Village	Kurayaravasithan (70)
Survey Number(s)	169
Taluk	Thiruchuli
District	Virudhunagar
Tank lying toposheet no.	58K/6
Hydrologic Part	
Cascade/Code	Pitchankudi Cascade/4A1D2/29
Sub Basin/Code	Gundar/4A1D2
Reg. Ayacut in ha. (38.29
Assessed)	
Wat sprd A at FTL in ha. Max. width of water spread in m	38.24
OrgnI capacity in MCM No of fillings	
Total Annual Storage in MCM	
Source of water supply	FB.Pulichikulam
Surplus goes to	Kuraiyaravasitan
Surplus through	big(17), Pitchangudi
Capacity of tank above in MCM	
Area of FB in sq.km	
No of Tanks Above	
Comb. catchment area in sq.km	3.8524
Max dis. from CCA in Cumec	
Water stored per ha. In MCM	
Total yield in MCM	
Dis. over total weir length- cumec	
Hydraulic Partic	ulars
Top width of bund in m

Side slope of bund H:V Front, Rear	
Length of bund in m	
Length of supply channel in m	
Length of weir in m	
No of sluice	
FTL (Full Tank Level)	Assumed 100.000
MWL (Maximum Water Level)	100.600
TBL (Tank Bund Level)	101.600
IBM	
II BM	
Sill level of sluice no.1 from LF	98.45
Sluice type	
Vent size in m	
Dia of plug in m	
Barrel size in m	
Ayacut in ha. for sluice no.1	
Note
